Today's Fukushima nuclear power plant

Report on Inspection Tour of the Fukushima Daiichi Nuclear Power Station

Co-representatives of the Physicians Against Nuclear War

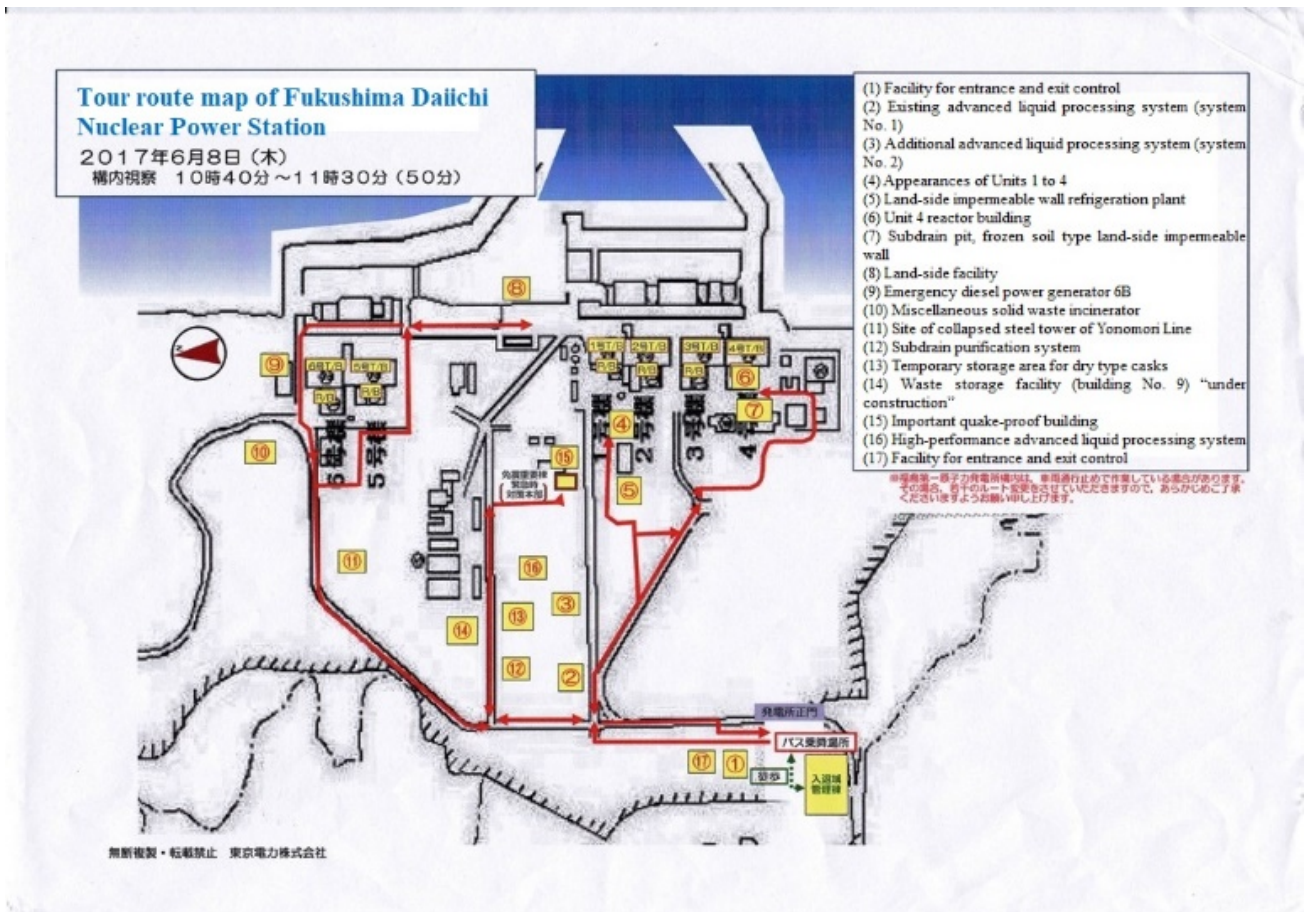
Tour route: We moved from the facility for entrance and exit control shown in the lower right area of the map to the sea side, observed Units 1 to 4, returned to the bus terminal, moved to the left sea side, and observed Units 5 and 6.

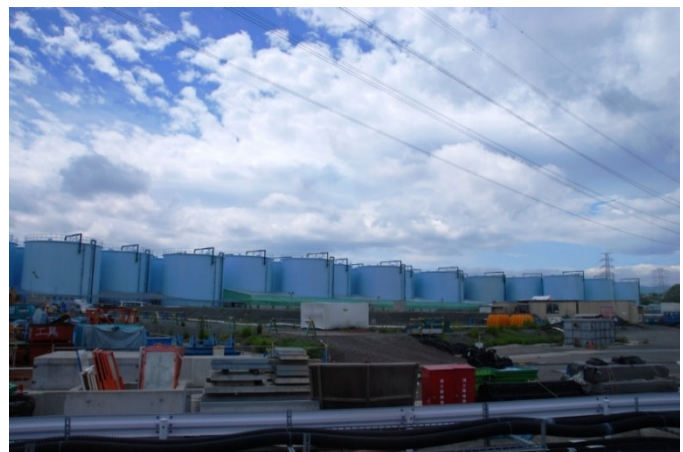
We got on a minibus for touring, and the tour began. We first saw many tanks ahead, in which contaminated water was stored. At present, about 900 tanks for storing contaminated water are installed. In earlier days, bolt-clamped flanging type tanks were used because of a shortage of tanks of appropriate types. These flanging type tanks were later replaced with welded type ones, which have been used to date, due to leakage problems. However, TEPCO staff told us that space for installing additional tanks will be no longer available in several years.

Tanks storing contaminated waters

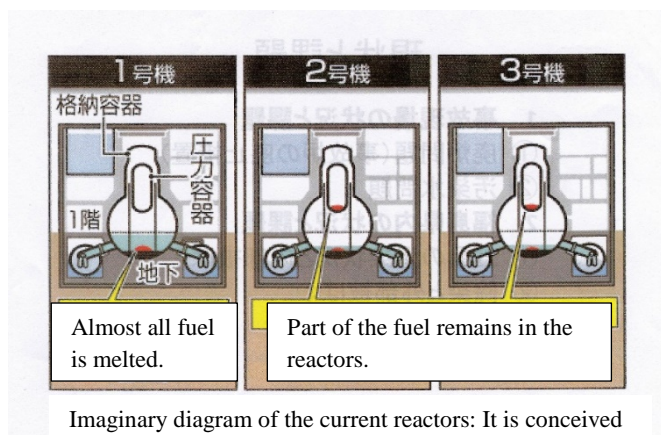
Imaginary diagram of the current reactors: It is conceived that Units 1 to 3 have caused a meltdown, and the fuel has melted the bottom of the pressure vessel and formed debris on the bottom of the containment vessel.

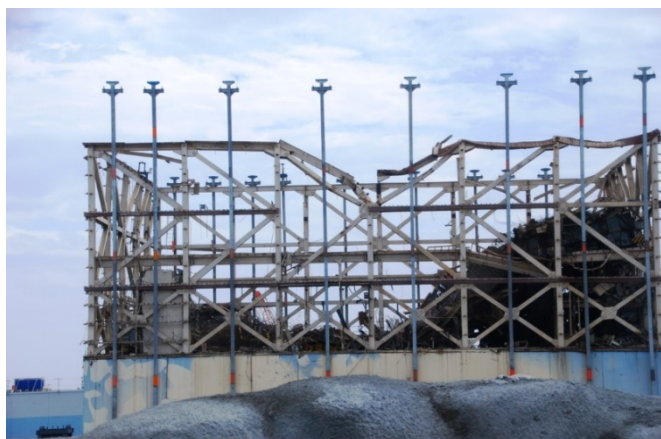
Unit 1 loomed up before us. Although we had seen its photos and videos over and over again, we were really shocked by how seriously it was devastated. Unit 1 was temporarily covered but is uncovered to remove spent nuclear fuel, and rubble is cleared away. Around the building are poles for water sprinkling during rubble removal work. TEPCO staff said that they will install windshield nets, start rubble removal, and, upon the completion of this work, by which the water surface of the fuel pool will become visible, fabricate fuel removal equipment to remove fuel.

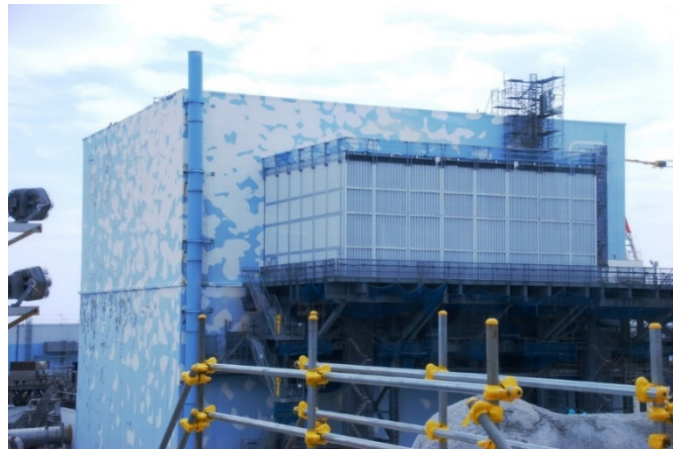
Unit 2 escaped being exploded and looked unchanged from what had been before the disaster, but it melted down because of the cooling system's failure to operate. A pre-clean room is prepared also for Unit 2 to dismantle its top floor for the purpose of removing spent nuclear fuel.

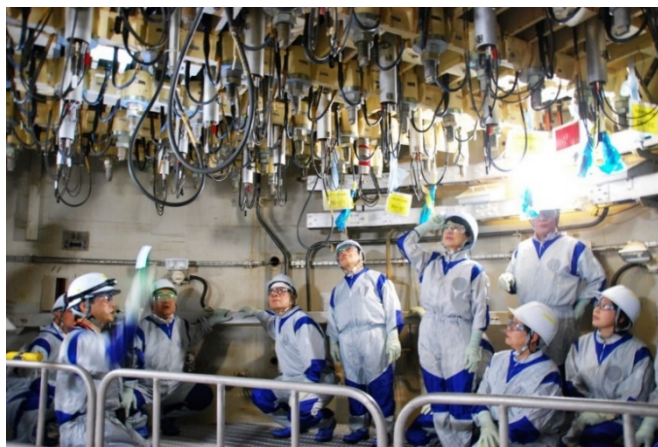
Below a pressure vessel.

Then, we changed our clothes into Tybek protective suits (coveralls) and wore socks, gloves, a helmet, and goggles, and observed the spent nuclear fuel pool on the top floor. Following this observation, we entered a nuclear reactor containment vessel and viewed the pressure vessel from immediately below its bottom. The containment vessel, the structure of which is the same as the containment vessels of the Fukushima Daiichi Nuclear Power Station, contained diverse devices in a complicated manner. We could easily imagine how hard it is to deal with serious situation resulting from the wreckage of these devices and the melted-down fuel debris.
